**Licensed Washington State Home Inspector. #229**

## **Inspection Report**

**PREPARED FOR: Office**

04/26/2011

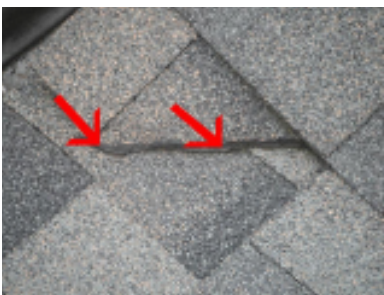
6. **Roof repairs are present which have been made with mastic/caulking:** Where Mastic, tar or caulking has been used for repair, it may only provide temporary benefits and will likely need periodic re-application. It is recommended a roofer evaluate the repair, evaluate for any hidden damages and provide a more permanent fix. *Be aware that hidden damages may exist which are outside the scope of inspection.*

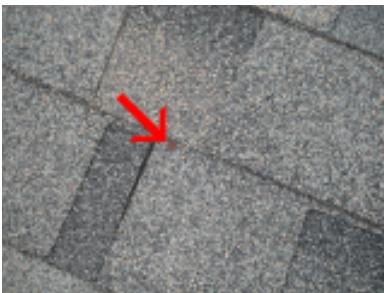
7. **There are exposed fasteners visible on roof surface:** Exposed fasteners should be repaired to prevent possible leaking.

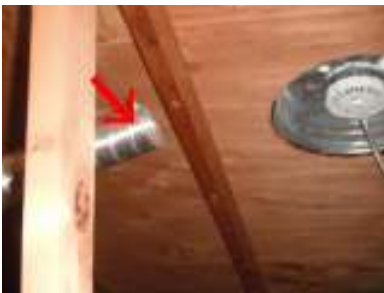
13. **Exhaust fan ducts disconnected or are not vented outside attic:** Exhaust fan ducts should be completely vented to the exterior in a dedicated and proper roof vent. A kitchen range hood not properly ducted to the exterior may allow flames from a kitchen fire to more readily access the attic space. The following ducts were disconnected or vented inside the attic: All observed.

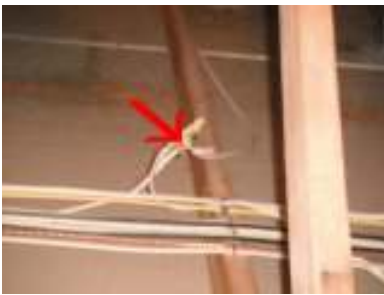
20. **Exposed wiring connections are seen:** For safety, wire connections should always be made in a proper, rated and covered junction box. Exposed wiring connections were seen in the following area: Attic space.

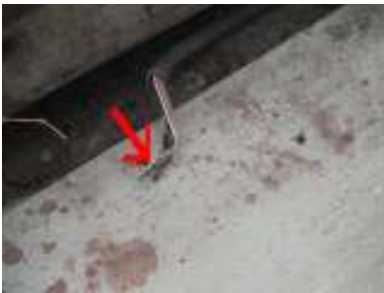
21. **Exposed bare wiring is seen:** For safety, any bare wire ends should terminate in a proper, rated and covered junction box. Exposed bare wire ends were seen in the following area: Primary structure and exterior rear..

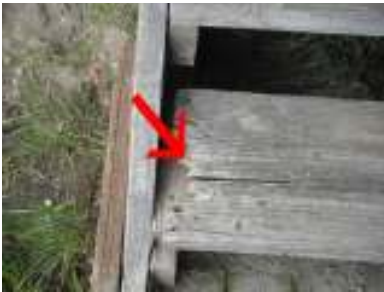
30. **There is decay to the deck stair risers.** This was noted in the following area: Rear.

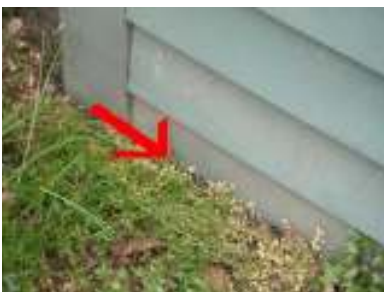
33. **There is earth to siding contact present= EW** Earth to siding contact should be eliminated as it may promote wood decay and infestation. Any dirt or landscaping material should be cleared away to provide at least 4 to 6 inches of clearance from the siding. Hidden conditions such as damage or infestation may exist and should be reported to the inspecting firm. This was noted in the following area, Front.

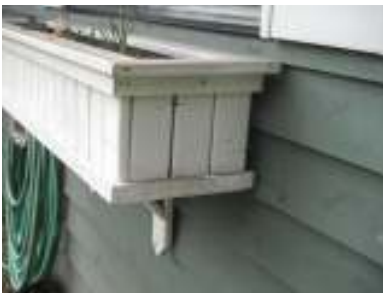
34. **Wood planter boxes have been attached to the structure.** The combination of soil, dirt and water may promote decay and infestation not only of the planter box, but of the structure as well. Removal is suggested. Be aware that hidden conditions may exist.

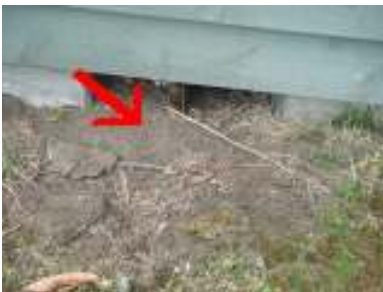
37. **Foundation vents are blocked.** Un-block any and all foundation vents which have been either purposely blocked and/or are blocked by landscaping material or dirt. Repair any damaged screen with 1/4 inch, *non-louvered*, galvanized hardware cloth. If vent is below grade, a foundation vent well should be installed to keep dirt and landscaping material clear of the vent. This was noted in the following area, Front

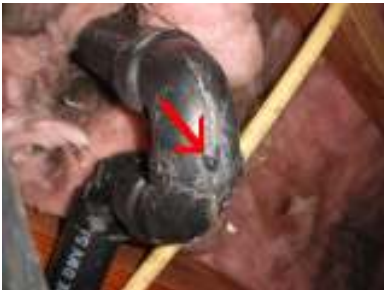
38. **A drain line leak is noted in the crawl space.** A licensed plumber should be called to make repairs. Drain leaking was noted in the following area: Under hall bath and kitchen.

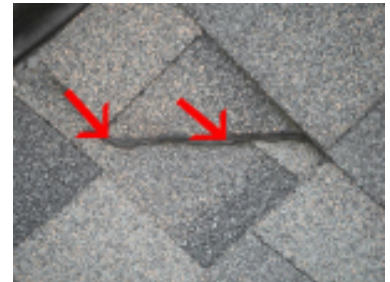
Mastic Repairs: Roof repairs are present which have been made with mastic/caulking: Where Mastic, tar or caulking has been used for repair, it may only provide temporary benefits and will likely need periodic re-application. It is recommended a roofer evaluate the repair, evaluate for any hidden damages and provide a more permanent fix. *Be aware that hidden damages may exist which are outside the scope of inspection.*

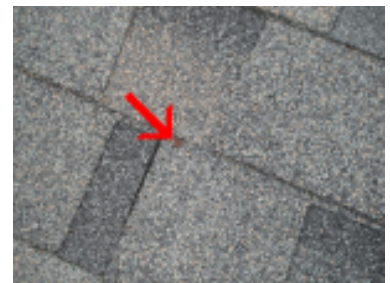
Exposed Fasteners: There are exposed fasteners visible on roof surface: Exposed fasteners should be repaired to prevent possible leaking.

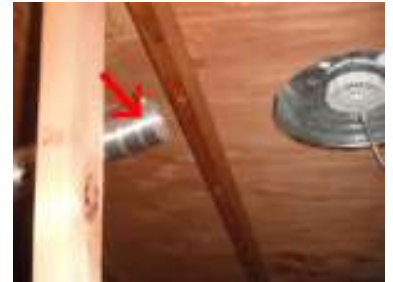
Exhaust fan ducts disconnected or are not vented outside attic: Exhaust fan ducts should be completely vented to the exterior in a dedicated and proper roof vent. A kitchen range hood not properly ducted to the exterior may allow flames from a kitchen fire to more readily access the attic space. The following ducts were disconnected or vented inside the attic: All observed.

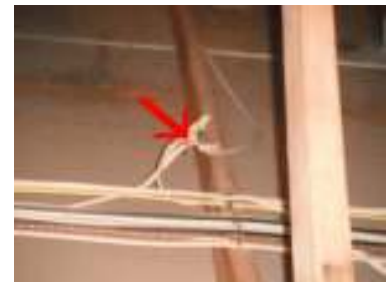
Open Connections: Exposed wiring connections are seen: For safety, wire connections should always be made in a proper, rated and covered junction box. Exposed wiring connections were seen in the following area: Attic space.

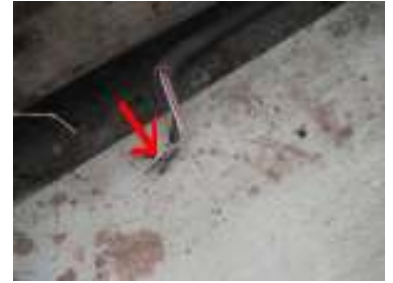
**Exposed bare wiring is seen: For safety, any bare wire ends should terminate in a proper, rated and covered junction box. Exposed bare wire ends were seen in the following area: Primary structure and exterior rear..**

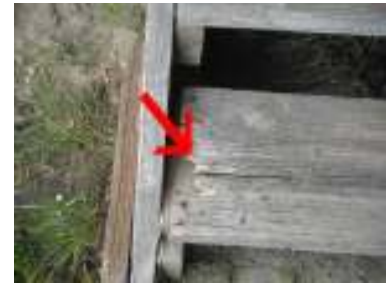
**Deck:** There is decay to the deck stair risers. This was noted in the following area: Rear.

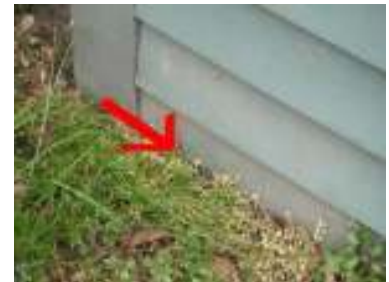
**Earth to Wood:** There is earth to siding contact present= EW Earth to siding contact should be eliminated as it may promote wood decay and infestation. Any dirt or landscaping material should be cleared away to provide at least 4 to 6 inches of clearance from the siding. Hidden conditions such as damage or infestation may exist and should be reported to the inspecting firm. This was noted in the following area, Front.

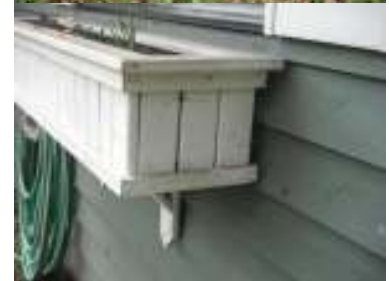
**Planters:** Wood planter boxes have been attached to the structure. The combination of soil, dirt and water may promote decay and infestation not only of the planter box, but of the structure as well. Removal is suggested. Be aware that hidden conditions may exist.

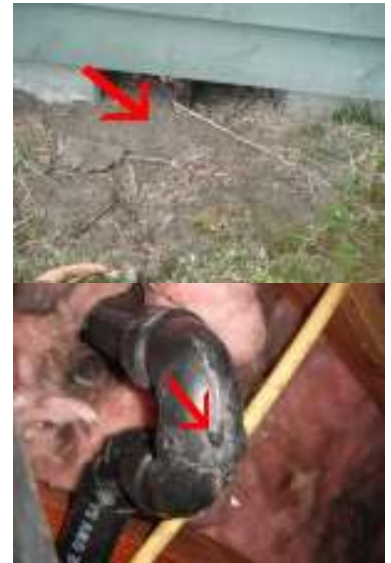
A drain line leak is noted in the crawl space. A licensed plumber should be called to make repairs. Drain leaking was noted in the following area: Under hall bath and kitchen.
